TECH-NIQUE

S-234

December 6, 1973

SUBJECT: 30B PLUS OSCILLATION

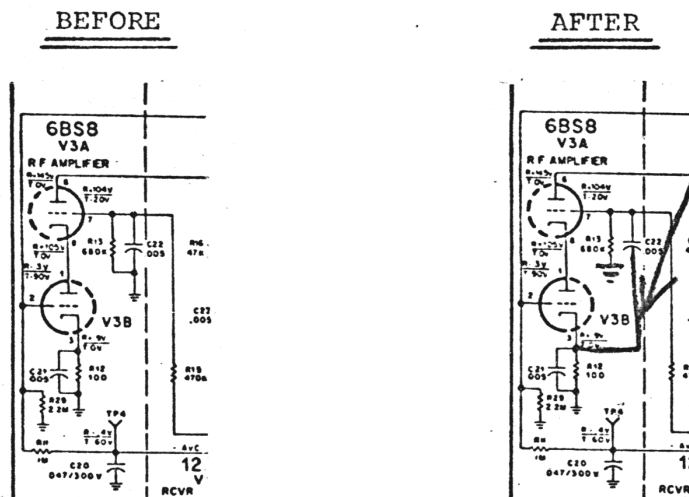
In some Transceivers, oscillation in the front end has been reported from the field. This is due to the high gain of the RF Amplifier.

The trouble can be corrected by changing the ground return of capacitor C22 (.005 MFD 500VDC) from the center post of the tube socket V3A to Pin 3 (Cathode) of V3B.
