# TECHNICAL SERVICE BULLETIN

## 10072

**MODEL(S):** 29 LX LE

**DESCRIPTION:** No display

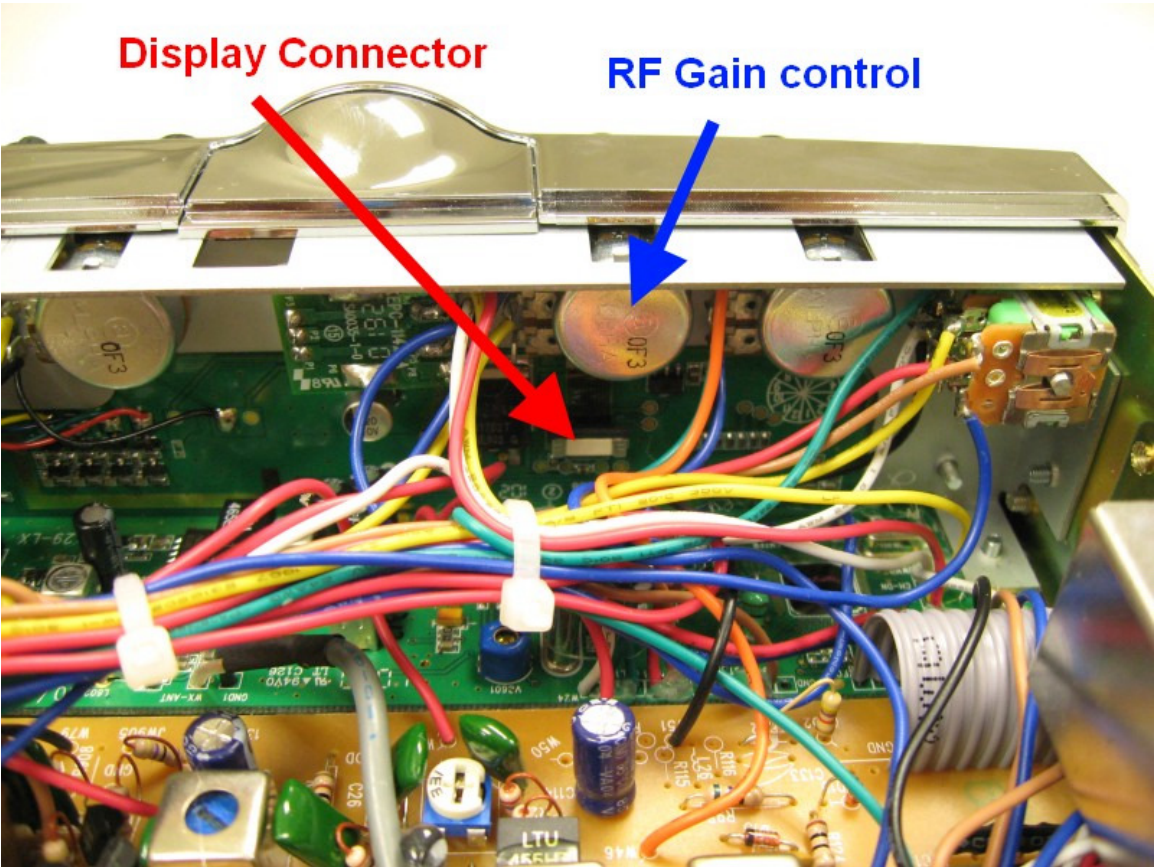
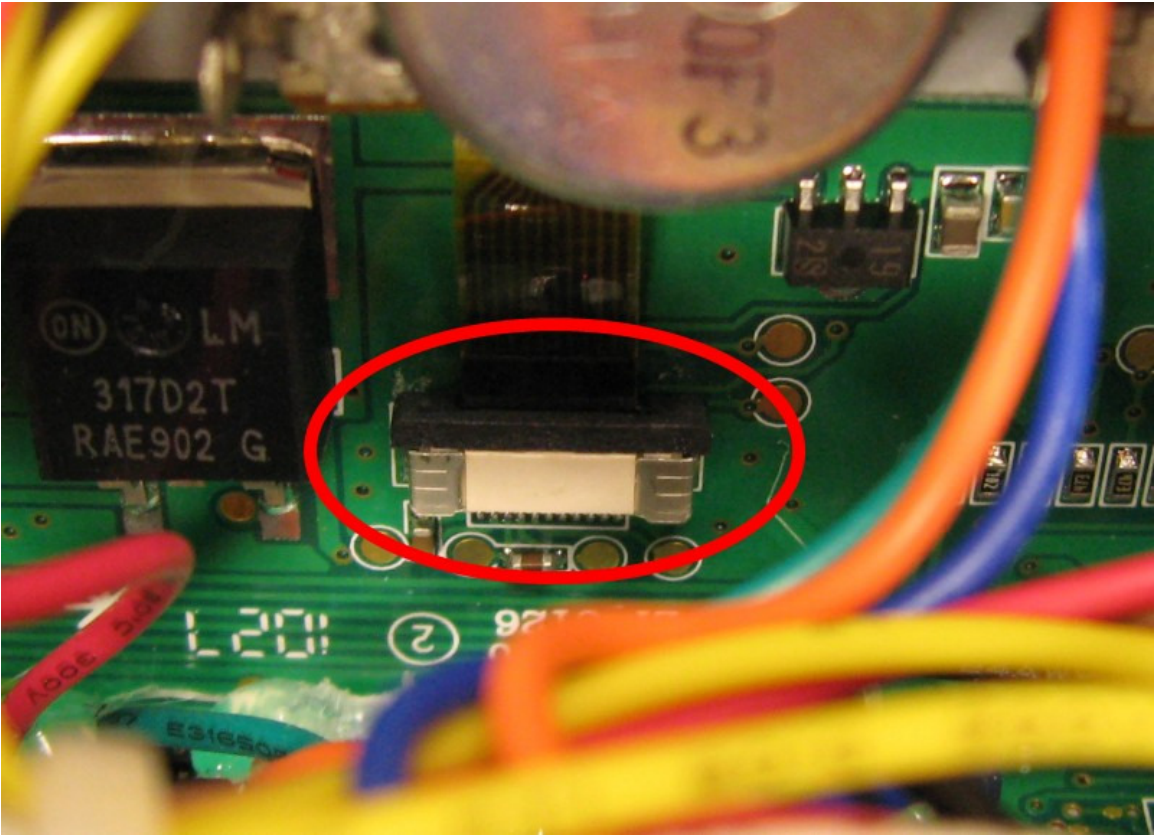
**ACTION:** There is a ribbon cable which runs from the display to the display PCB. If this cable becomes loose then you may loose the display. Or the display may become intermittent.

The following pages shows the location of the ribbon cable. Make sure that the cable is fully seated into the connector. Please note that the connector has a locking mechanism. Lift up on the top piece to release the lock, and push back down to engage the lock.

1. Lift up on the top piece to release the lock (see page 3).
2. Use the eraser end of a pencil to push the ribbon cable all the way down.
3. Push down on the top piece to engage the lock.
